# Final Environmental Impact Statement for the Disposal and Reuse of the Department of Defense Housing Facility Novato, California

FINAL  
ENVIRONMENTAL IMPACT STATEMENT FOR THE  
DISPOSAL AND REUSE OF DEPARTMENT OF DEFENSE HOUSING FACILITY  
NOVATO, CALIFORNIA

VOLUME II

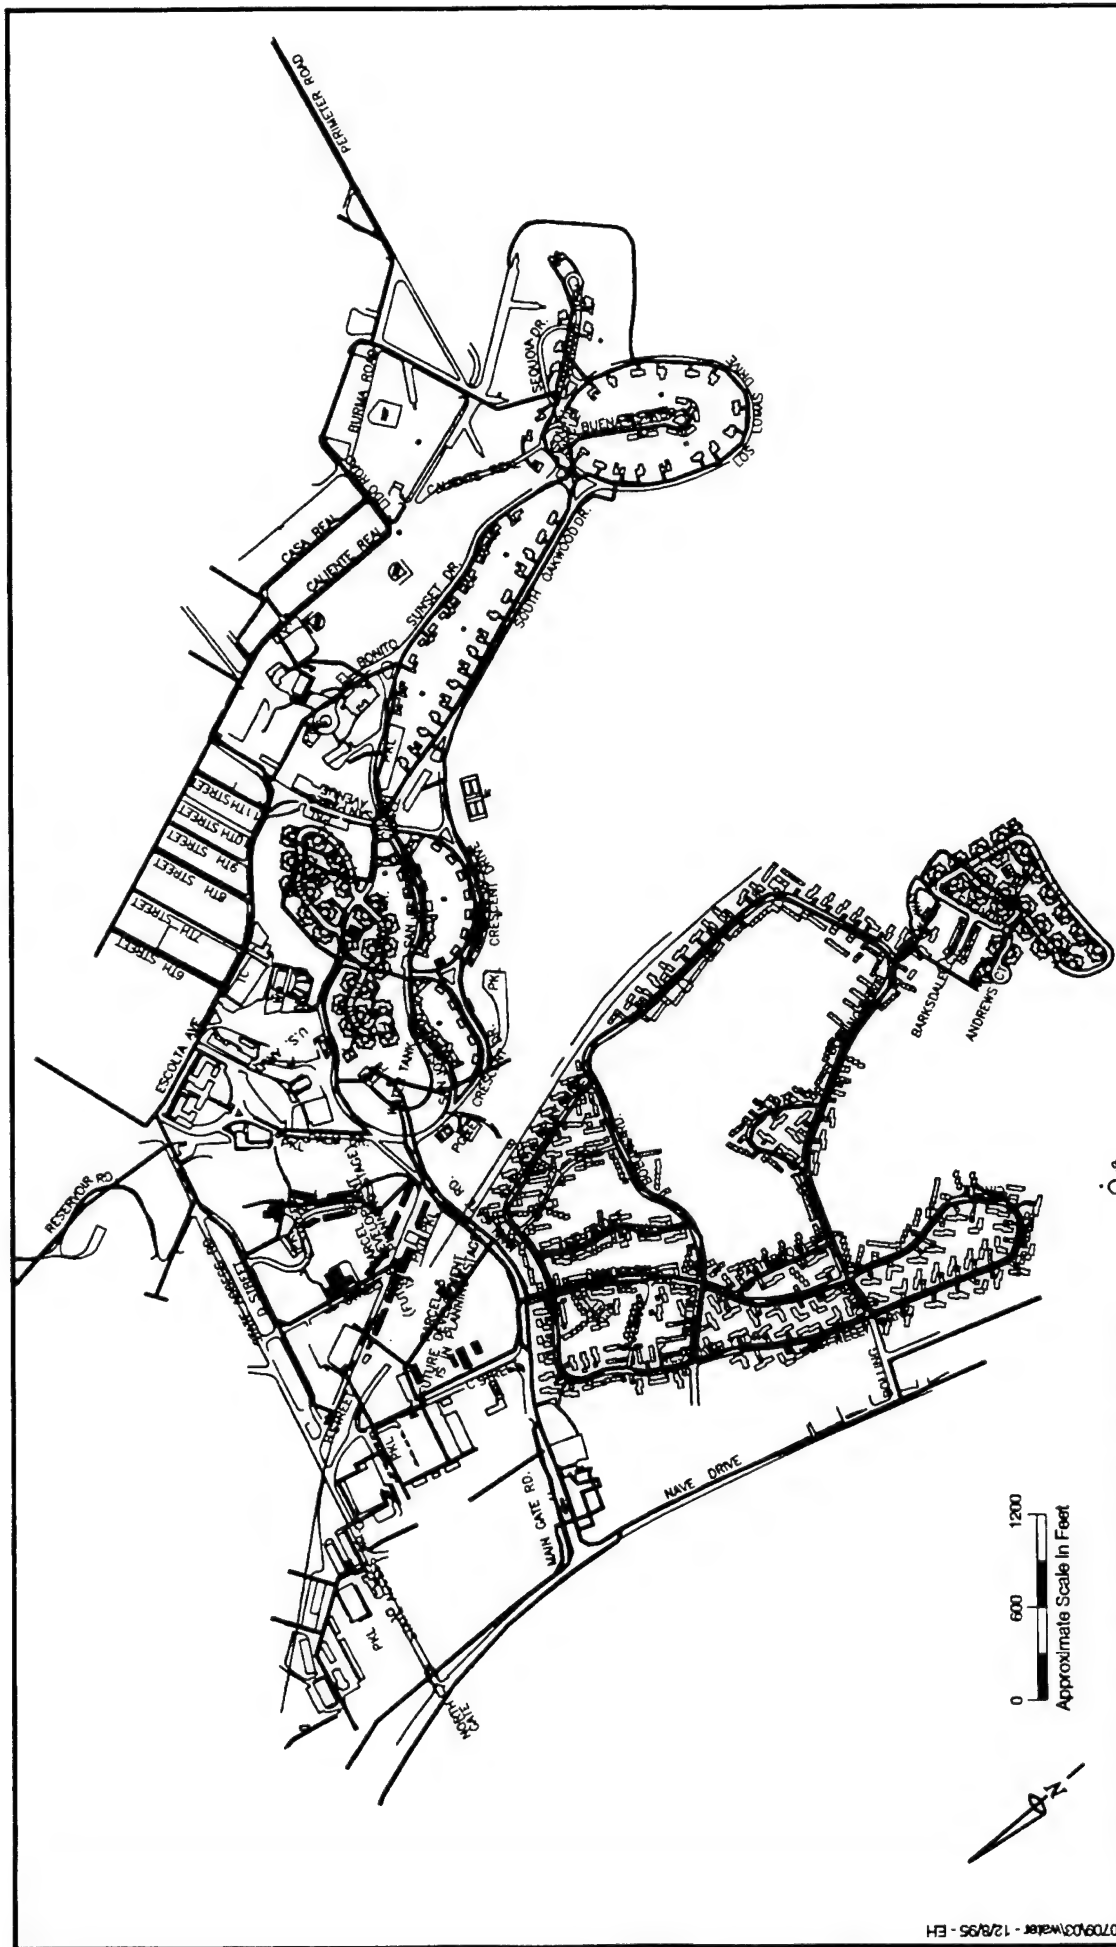
# Main Site Water Distribution System

The Marin Municipal Water District provides potable and fire protection water to the DODHF Main Site, with the exception of a portion of Capehart Housing serviced by the North Marin Water District.

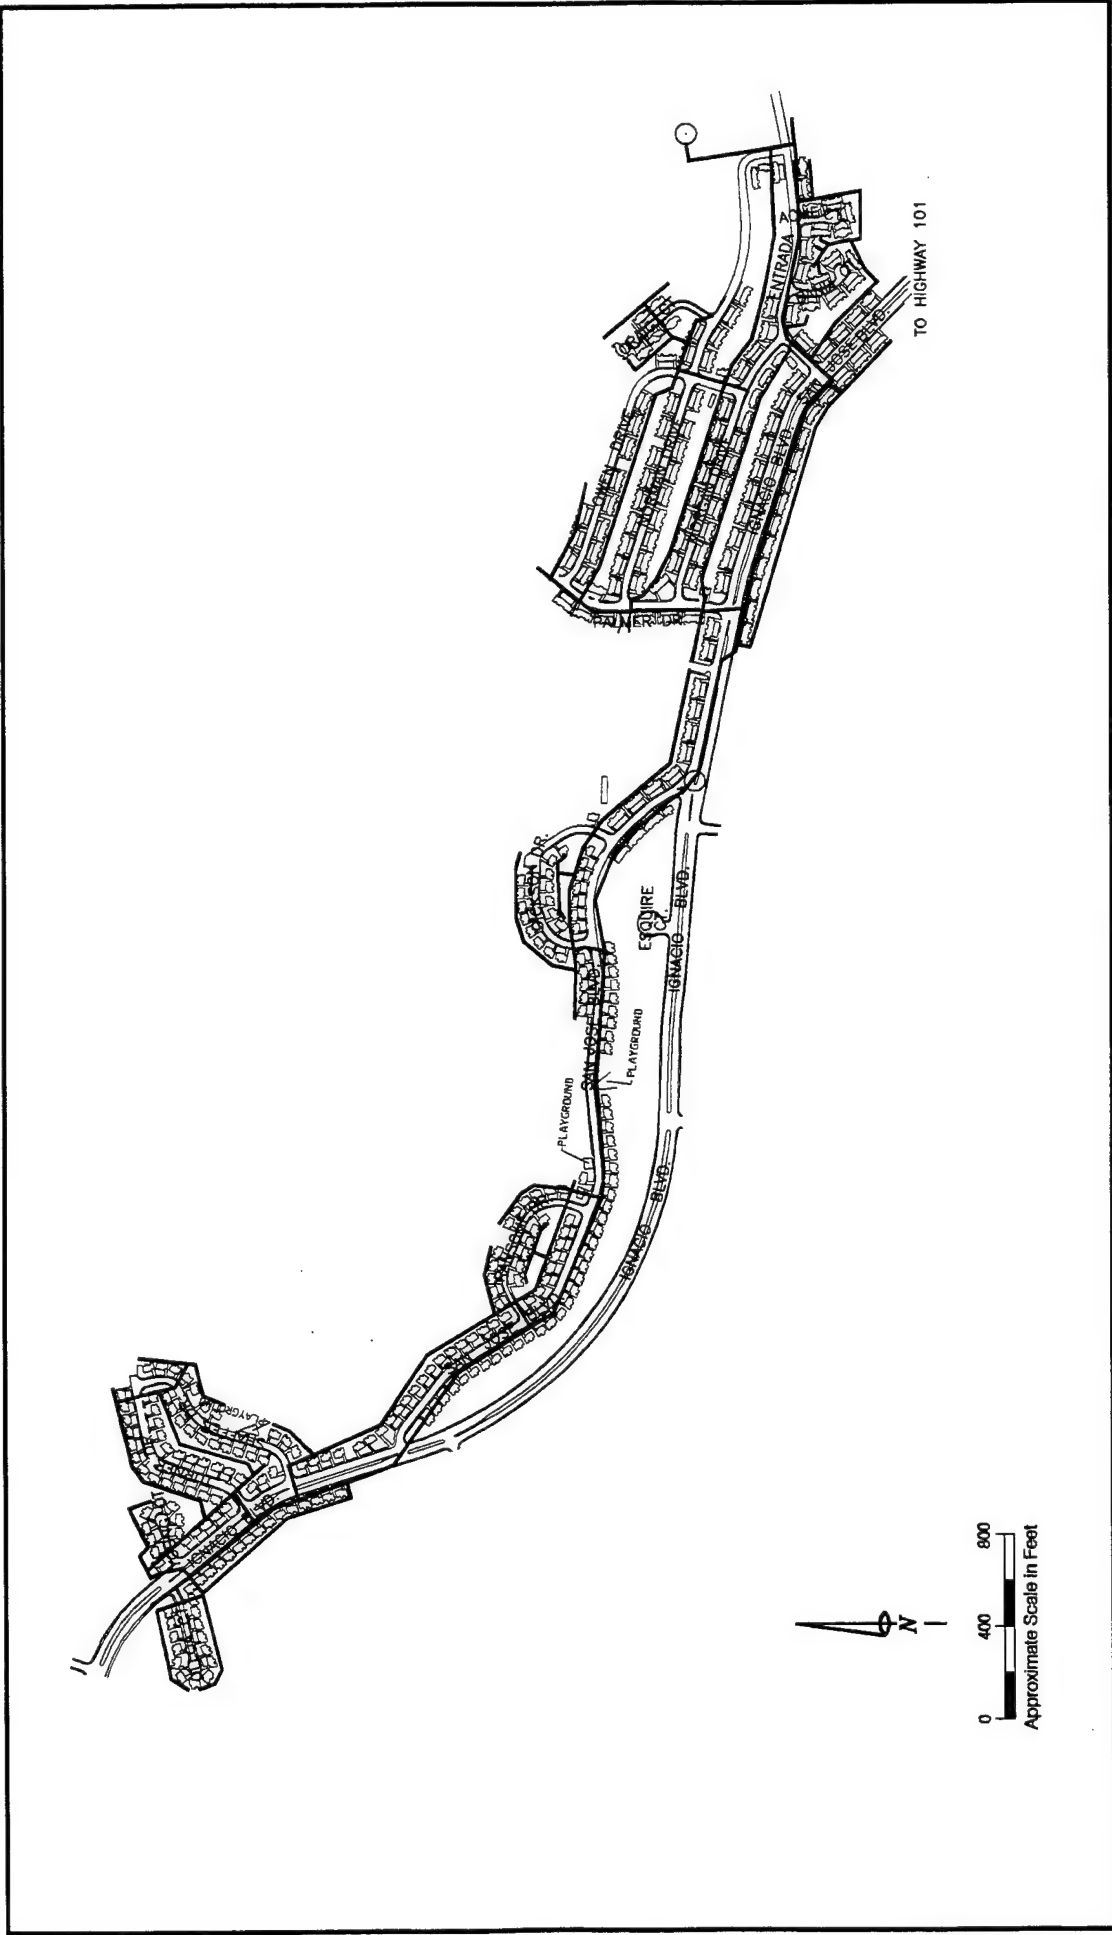
## Rafael Village Water Distribution System

The North Marin Water District provides potable and fire protection water to Rafael Village.

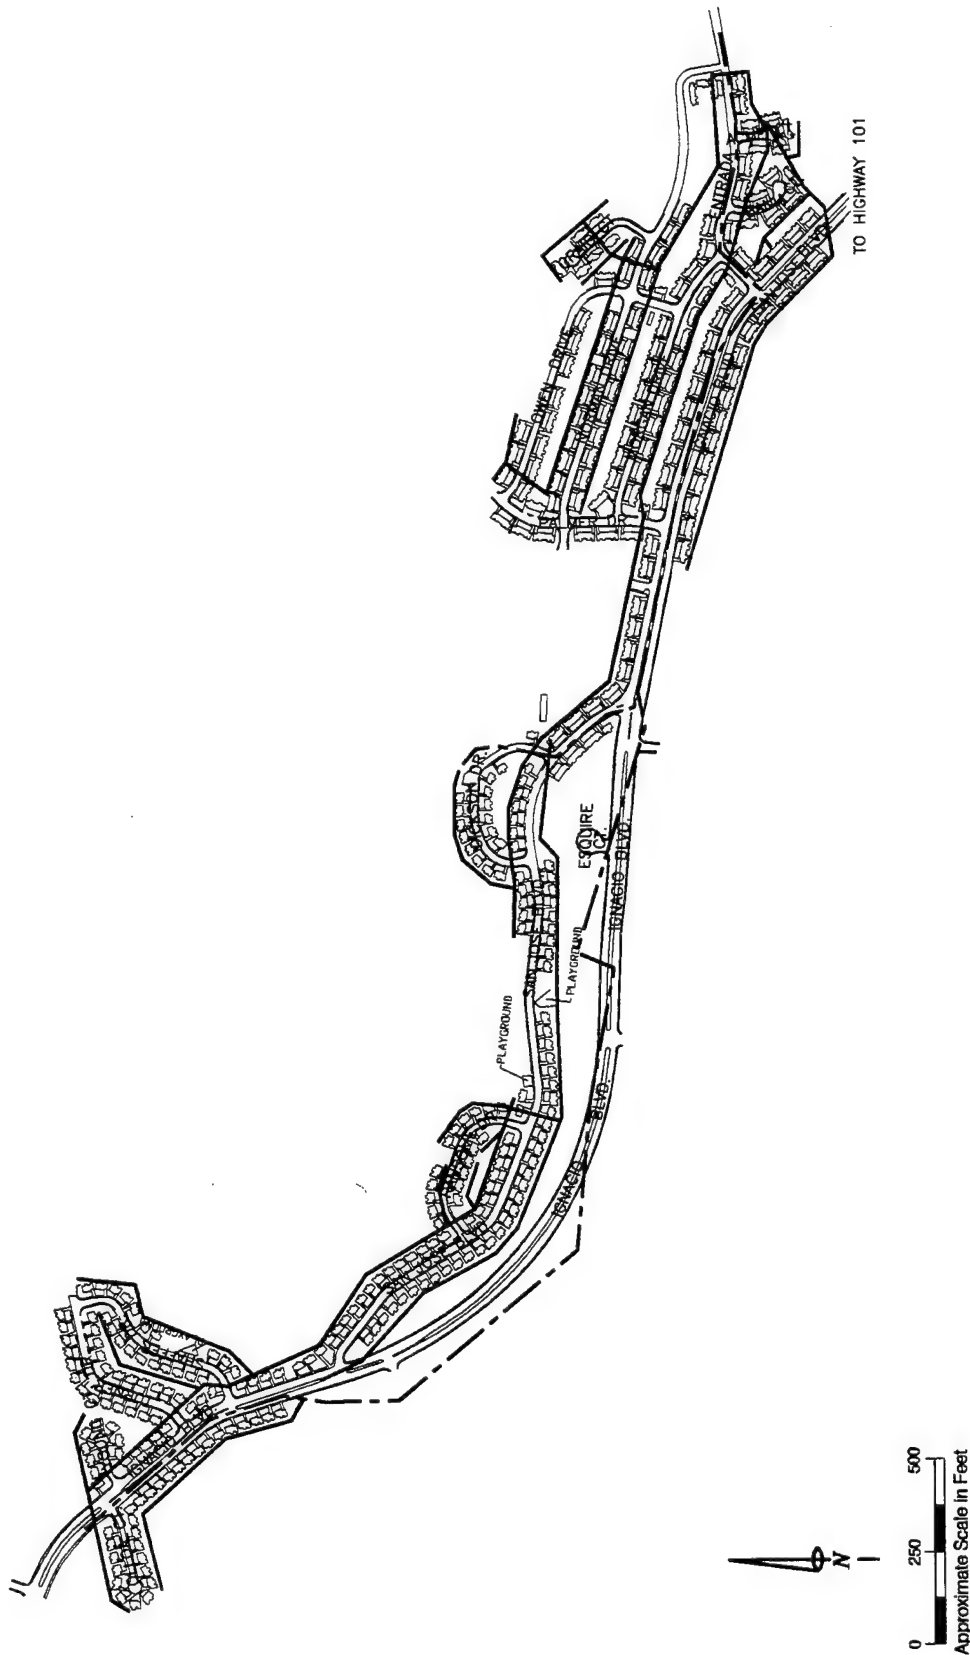
# **Rafael Village Sanitary Sewer System** DOD Housing Facility Novato, California

Sanitary waste from Rafael Village is discharged to the Novato Sanitary District sewer system for treatment at the Ignacio Sewage Treatment Plant.

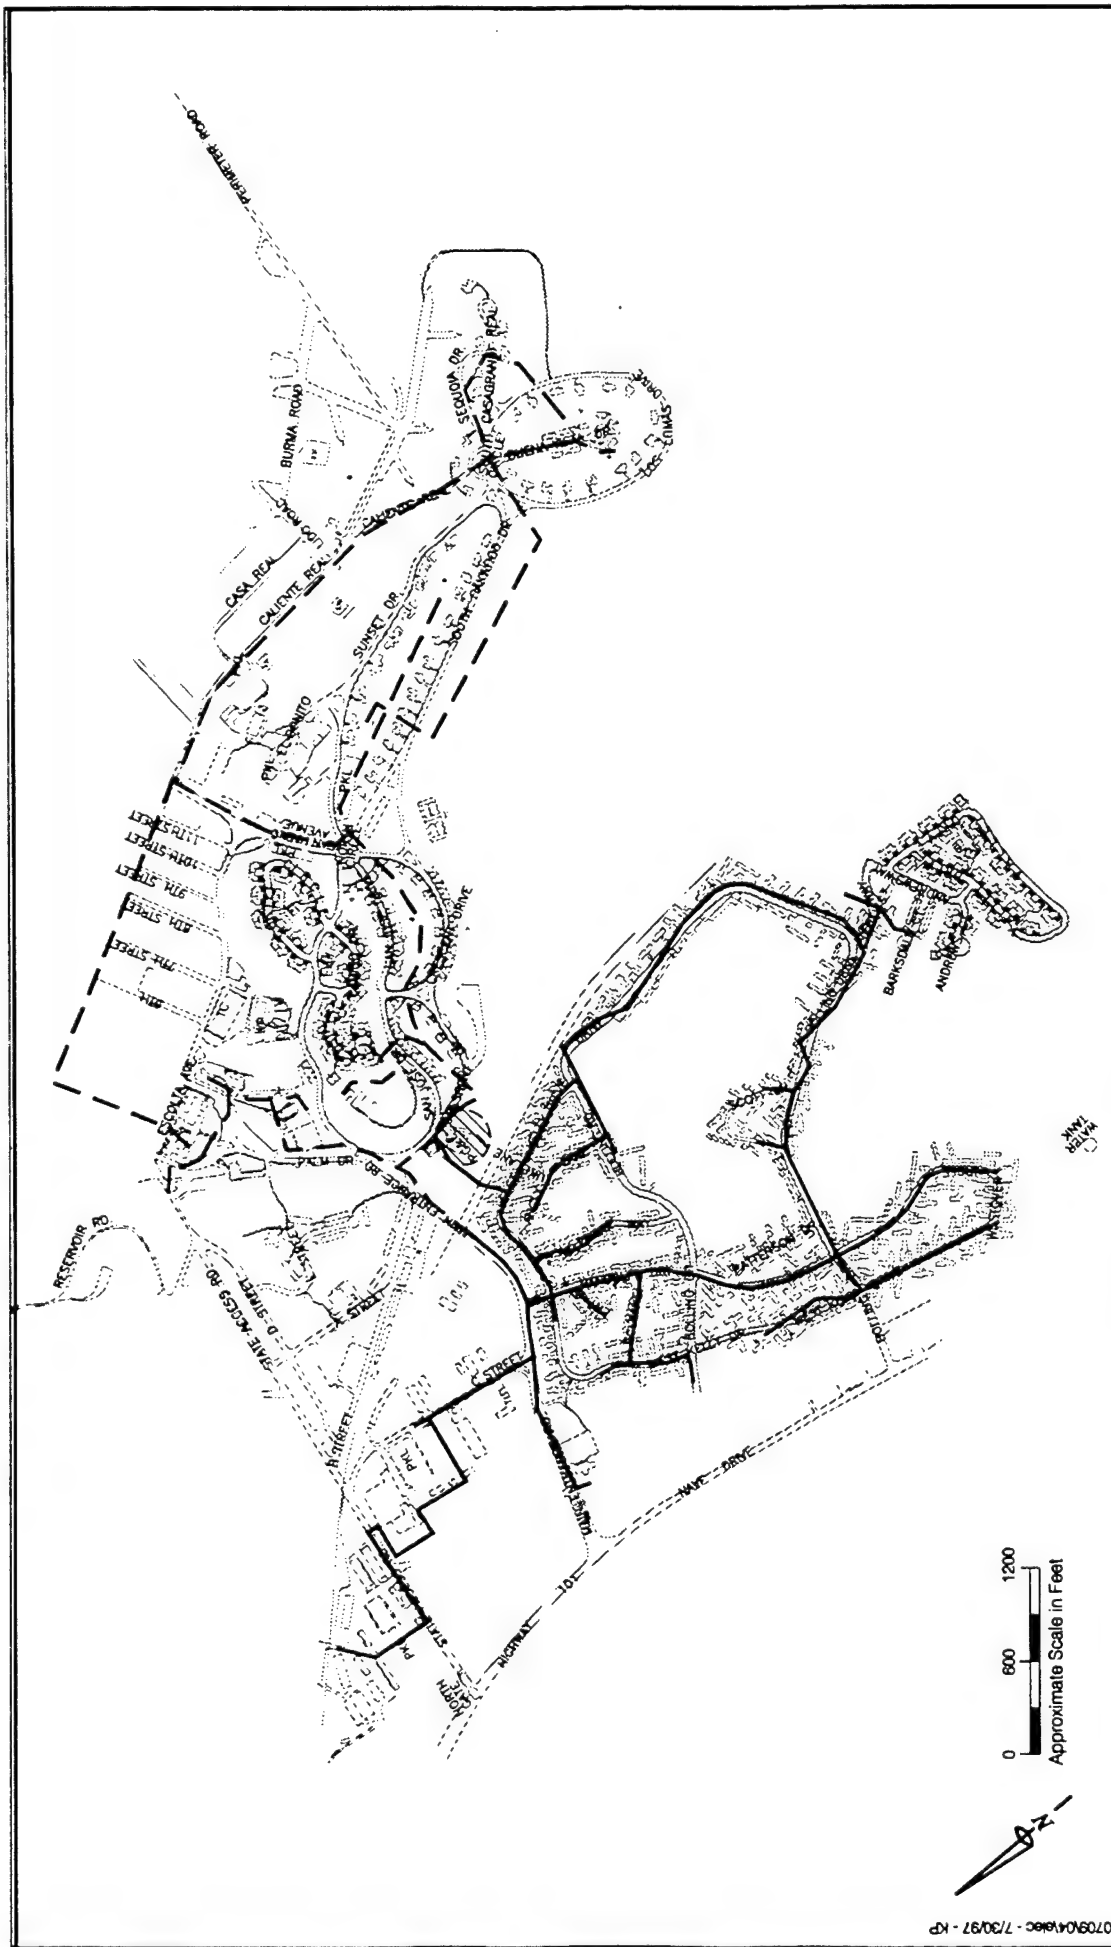
**Figure D-3a**

The Main Site electrical system, which receives power from PG&E, is owned and operated by the Navy Public Works Center San Francisco Bay. Power is delivered at 60 KV to the substation and reduced to 4.6 KV through the use of three 1,500 KVA transformers.

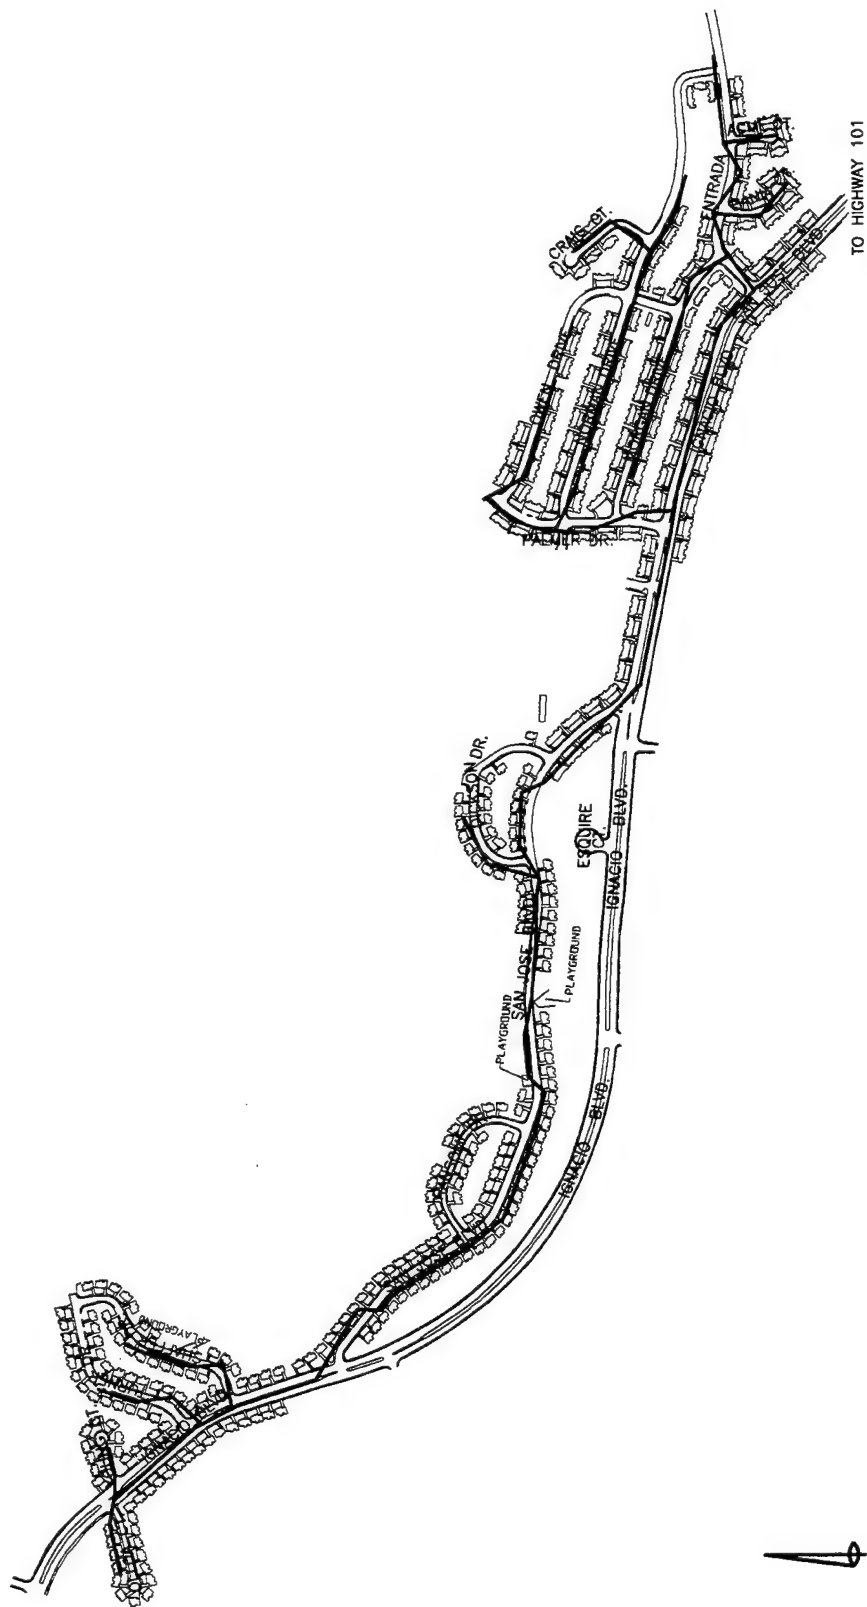
PG&E owns and maintains the electrical system at Rafael Village.

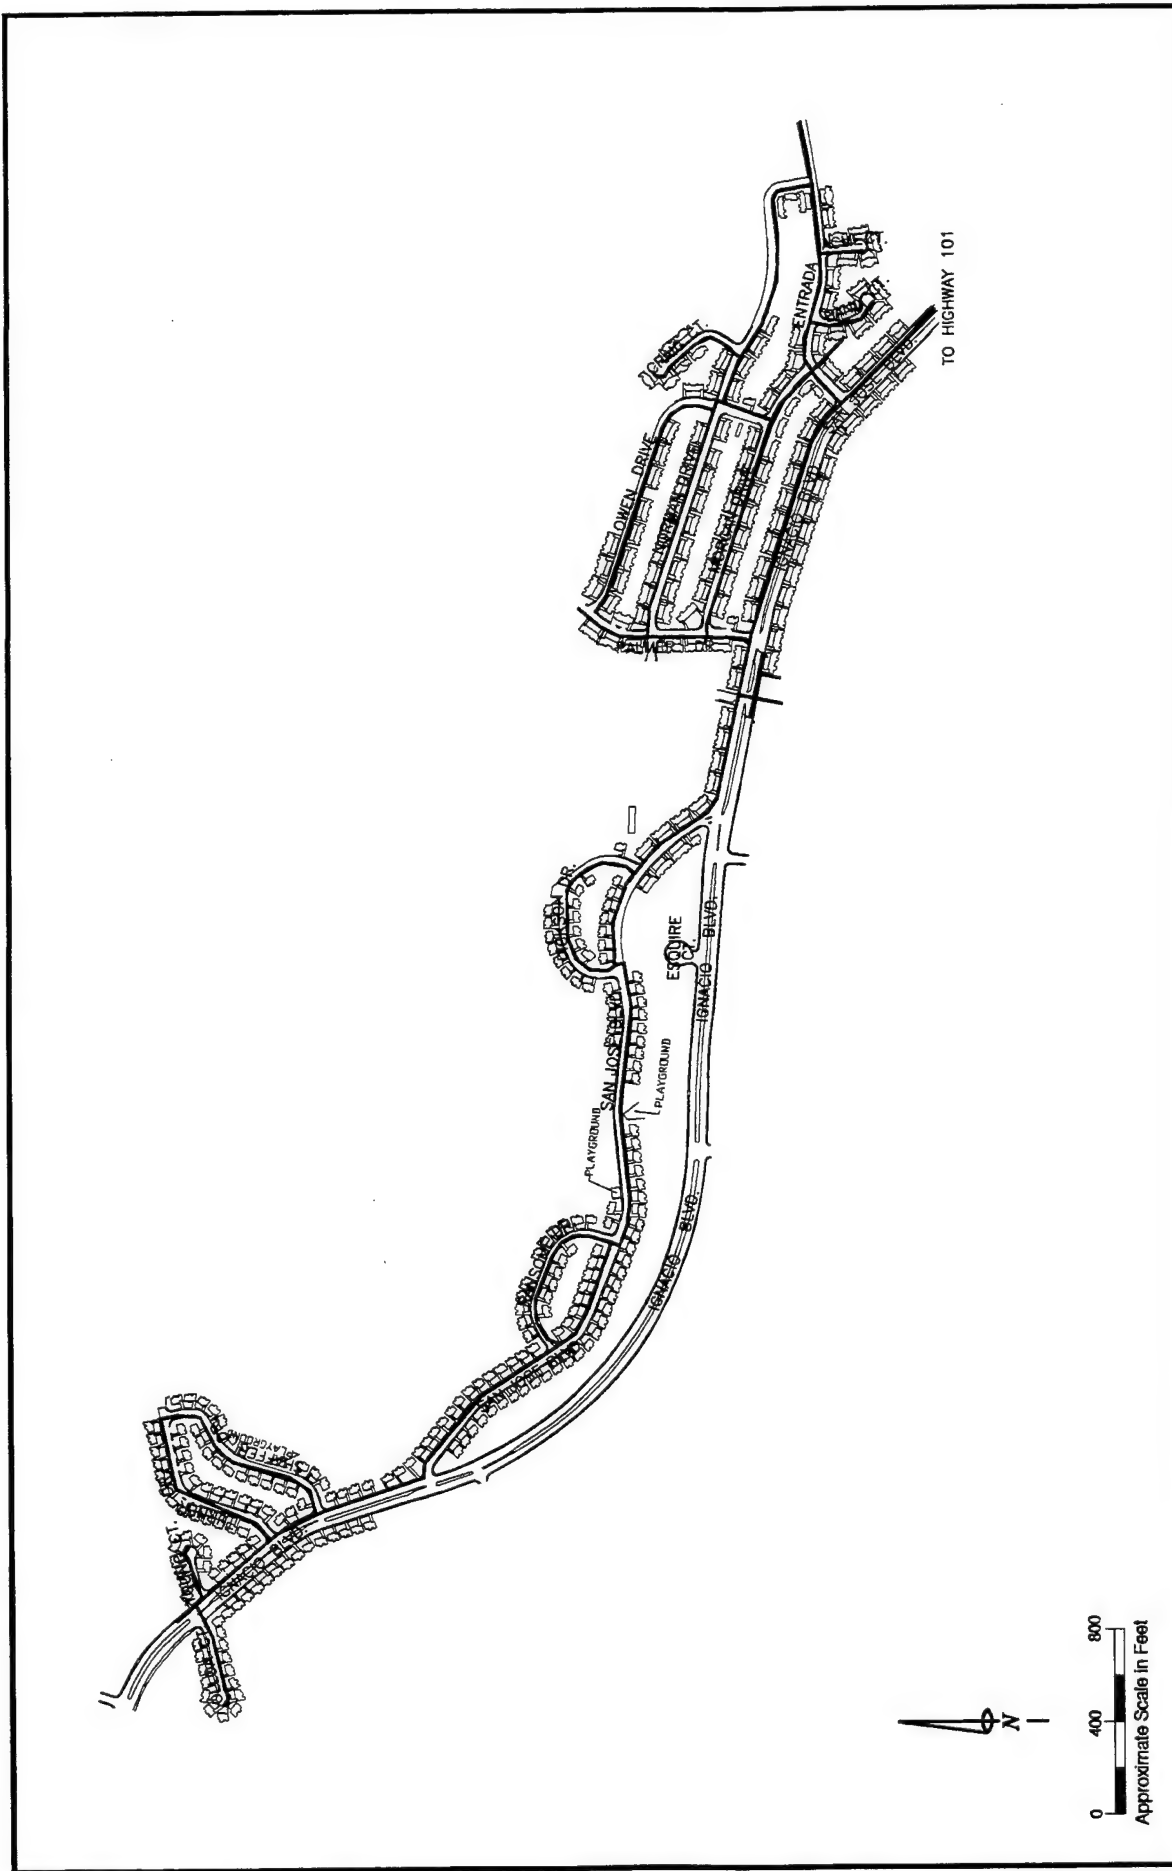
**Figure D-4b**

**Rafael Village Natural Gas System**  
 DOD Housing Facility  
 Novato, California

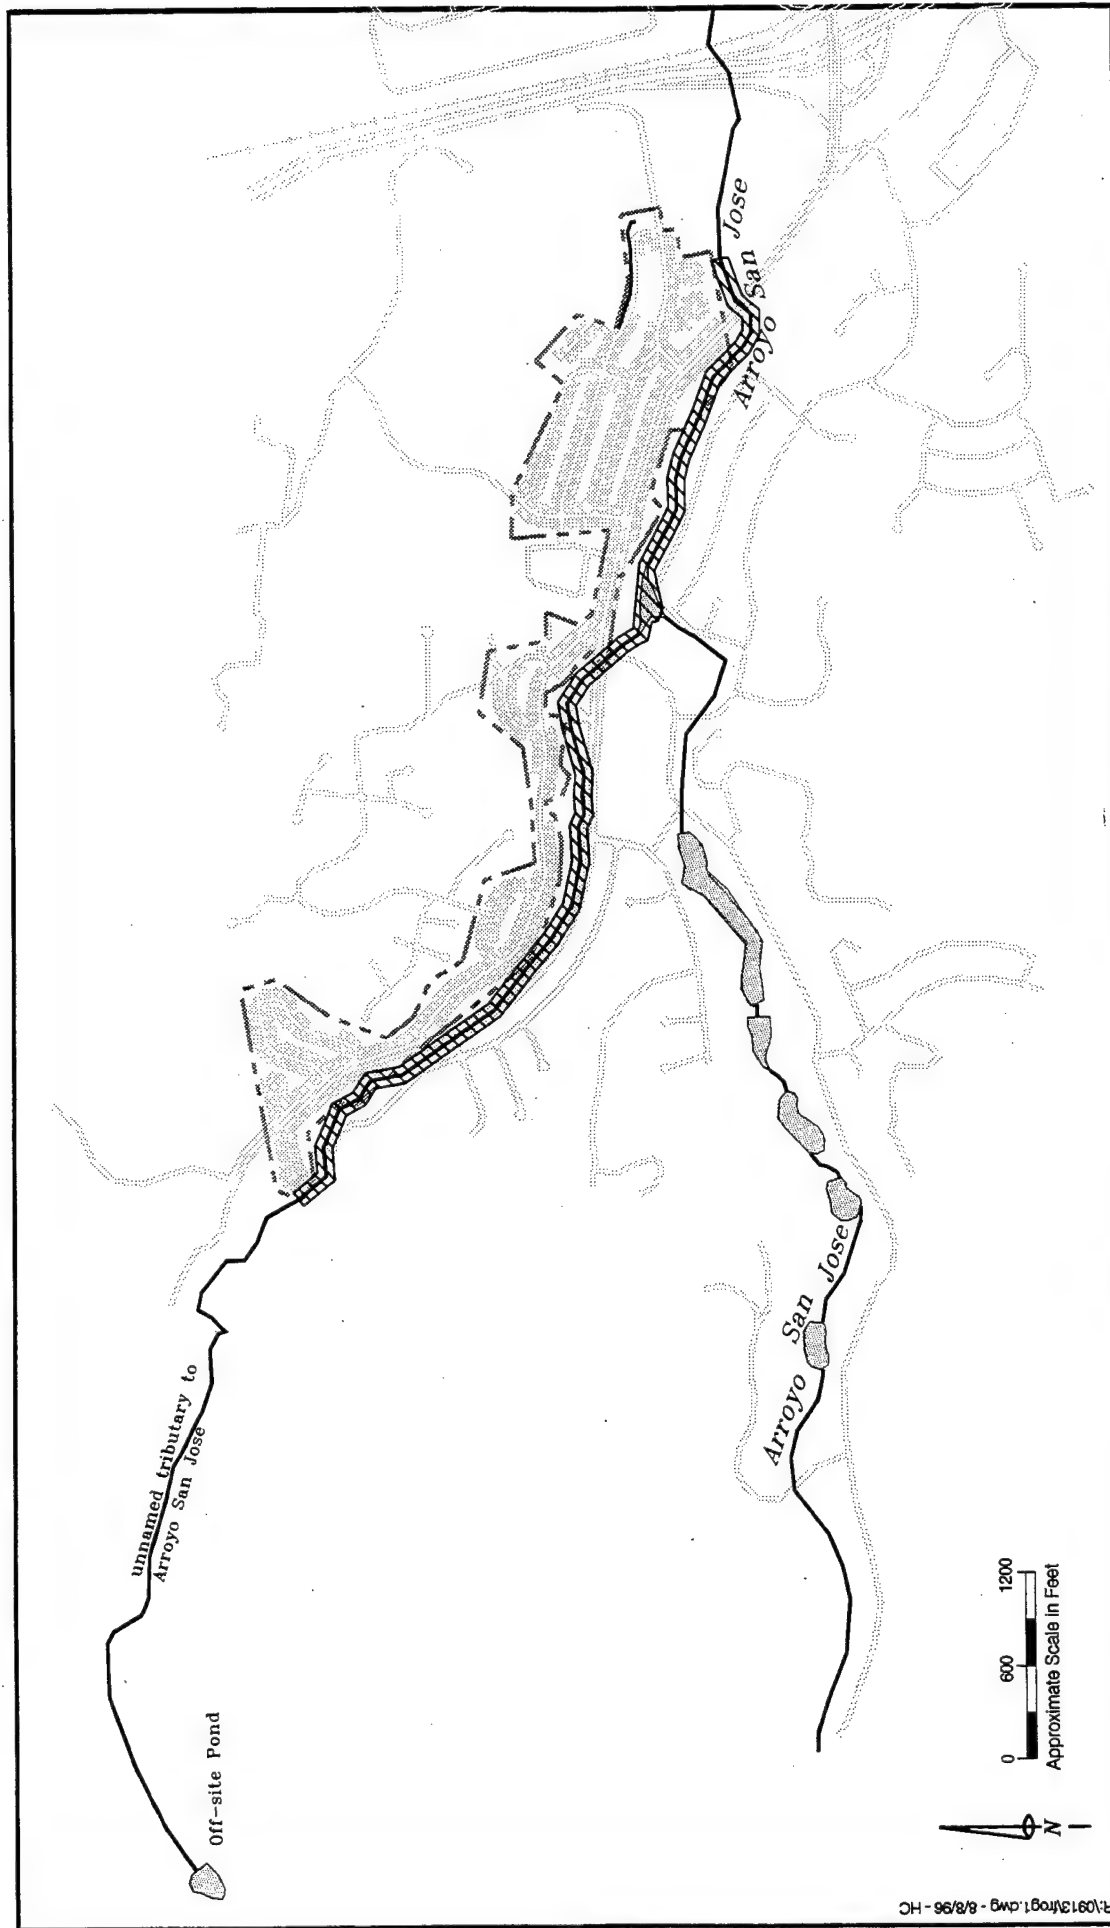
**Figure 3**

Surveys for red-legged frogs were conducted along Arroyo San Jose and an unnamed tributary to Arroyo San Jose adjacent to the Rafael Village planning area.

# **Rafael Village Survey Areas and Wetlands** DODHF Novato Red-legged Frog Surveys Novato, California

All wetland areas at DODHF Novato were identified during previous studies (Buescher Biological Consulting 1996). On April 10, 1996 the suitability of each of the wetlands to provide habitat for the red-legged frog was assessed. All wetlands that provide potential habitat for the red-legged frog were surveyed by Karen Swaim and David Muth on April 10, 22, 29, June 9, and July 24, 1996. Specific survey areas identified during spring surveys (April) as having potential to support red-legged frogs included Arroyo San Jose in the Rafael Village planning area, an unnamed tributary to Arroyo San Jose, Pacheco Creek along the west side of the Capehart Housing area, the northwest corner of a wetland in the southeast corner of the Capehart Housing area, and the ditches, canals, and associated wetlands that run along the western, southern, and eastern boundaries of the Spanish Housing area (Figures 3 and 4).
